Proper Seating of an Implant One Abutment

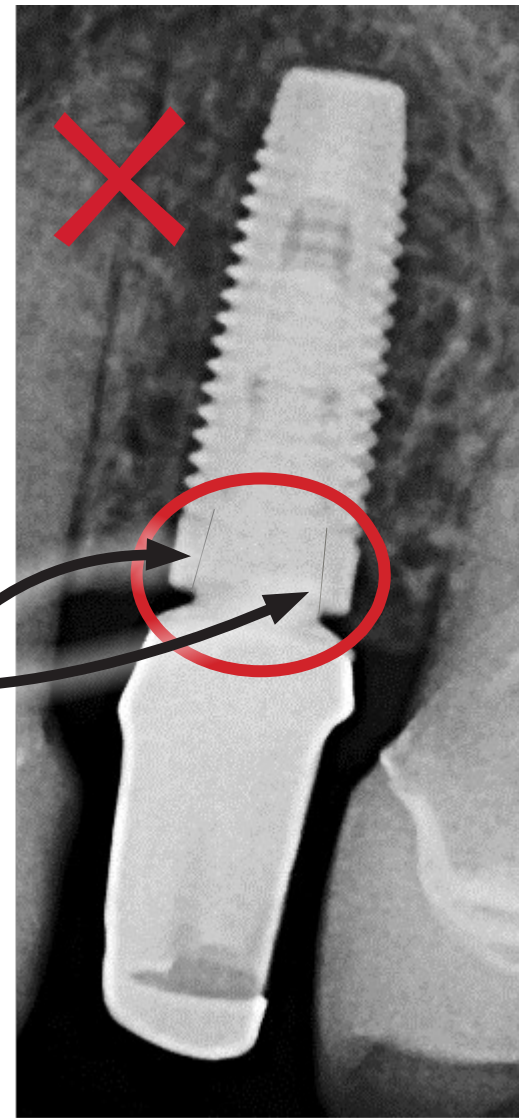
When any gap is visible the connection is not properly seated

A gap between the implant and abutment is normal. Ideally soft tissue will fill this space.
